# Focus on Safety

# Care of Polycarbonate Windows in Tigercat Operator's Stations

- Robin Barker, engineering administrator

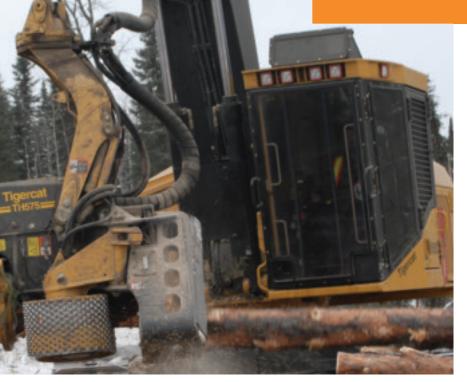
The thickness of the material used in a particular cab window is determined by a number of factors including the size of the window opening and the proximity to a safety hazard.

Polycarbonate windows used in Tigercat operator's cabs range in thickness from 9-32 mm (0.375-1.25 in). Properly designed and installed, polycarbonate windows do not require external steel mesh safety guards. This results in enhanced operator visibility.

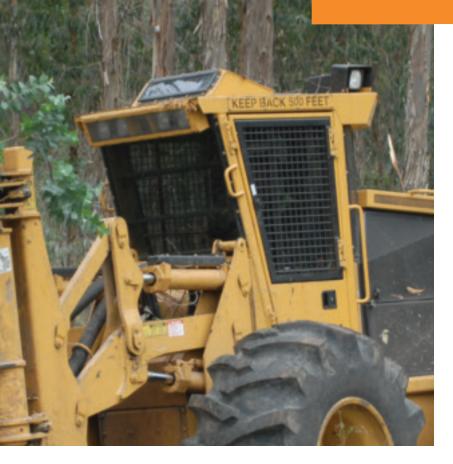
Unlike the tempered glass sliding side windows on the drive-to-tree feller buncher cab, the polycarbonate windshield and skylight do not require external steel mesh guarding. It is important to visually inspect polycarbonate windows daily. Cracks, chips and scarring will compromise the window's ability to withstand a significant impact.
